Oxidation Damage Analysis of Ferritic Alloy Steel Heater Tubes in Catalytic Reforming Unit

Article in *International Journal of Heat and Technology* · April 2024

DOI: 10.18280/ijht.420204

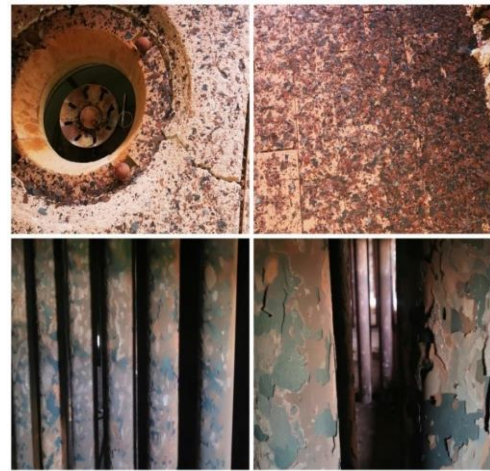
Figure 3. Inspected radiant tubes

Visual inspection revealed that the radiant heater tubes have severe scale layers and are fragmented by thermal oxidation. It is illustrated in the photograph in Figure 3, taken from different areas of the fired heater.

The results of this study indicate that the radiant heater tubes are damaged by thermal oxidation. Experimental results show that the tube was exposed to excessive temperatures, which led to corrosion of the external surface. The high temperature and the presence of excess oxygen in the atmosphere contributed to the oxidation of the tube, which extended over the entire length of the tube, and it can be accelerated by over-firing or internal fouling of the tubes. Under these conditions, oxide scale accumulates on the heater tubes, reducing their efficiency and increasing the risk of tube failure. The build-up of scale acts as an insulator, reducing heat transfer and increasing the surface temperature of the tubes, leading to reduced thermal efficiency.

1. Apply coatings to the internal surface of the heater tubes, such as thermal coating (TBC), to prevent fouling and reduce the formation of internal deposits. This helps maintain efficient heat transfer and prevents conditions that could lead to accelerated external oxidation.
2. Installing selective catalytic reduction (SCR) to enhance the combustion system with cutting-edge technologies. This will increase combustion efficiency and lower the production of hazardous byproducts like excess oxygen. This maximizes energy use while reducing the chance of oxidation.

3. Maintain the heater at the recommended levels of temperature. It is important to monitor and control the temperature of the furnace to prevent excessive heat exposure. This can be achieved by regularly checking and adjusting the temperature controls and by ensuring that the heater is operating within the manufacturer's recommended temperature range.

9. Avoid over-firing: Over-firing can lead to excessive temperatures and accelerate the oxidation of the tubes. To prevent overfiring, it is important to monitor fuel consumption and adjust the burners accordingly.

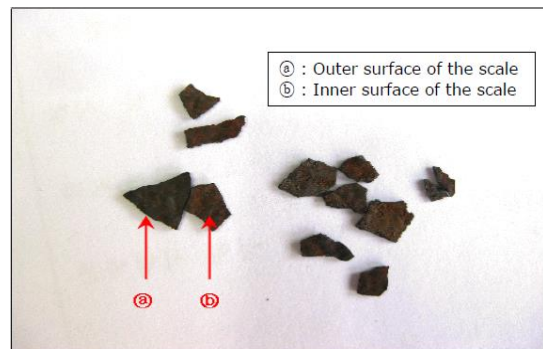
Figure 4. Dark scale fragment samples taken from the heater tubes

The Figure 4 represents the dark-scale fragment samples that have been taken from reforming unit heater tubes at the Skikda refinery in Algeria. Sample A corresponds to the outer surface of the scale, while sample B corresponds to the inner surface of the scale.

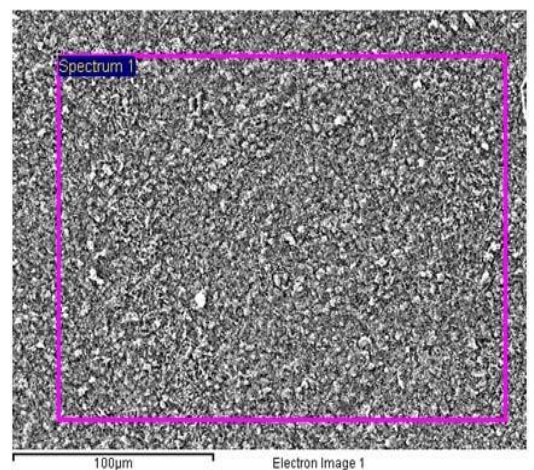
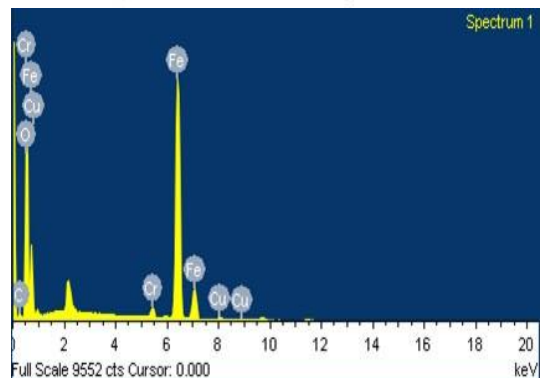
Figure 5. Energy dispersive spectrometer results from sample A of spectrum 1

The carbon content is higher than the range specified by ASTM in the area that corresponds to the spectrum of the sample (a), with a value of 2.64 in mass percentage and lower values in the other spectra, suggesting potential contamination or variations in carbon content due to factors such as processing conditions or environmental exposure.

After analysis, energy dispersive X-ray spectroscopy revealed the presence of copper, indicating its penetration during combustion and pointing to pure thermal oxidation. Additionally, the results of the replica test have shown that the heater tubes are not carbonized, and no signs of creep have been observed. The mechanical properties were evaluated through hardness and wall thickness measurements, confirming that the values met the required specifications. Moreover, these findings provided no indication of carburization or metal dusting. No bulged tubes were detected during the visual inspection.

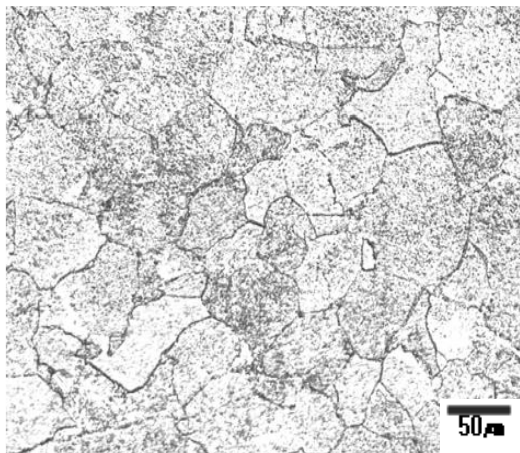
Figure 9. Microstructure of the tube A-37

Transformed large spheroidal Fe₃C carbide participates are observed in the above microstructure. Fe₃C carbides in grain boundaries are coarsened. The degradation degree of tube A-37 is evaluated as being in grade D. We can observe that there is no detection of creep cavities, micro-cracks, inclusion, or segregation. The tube is not carburized.

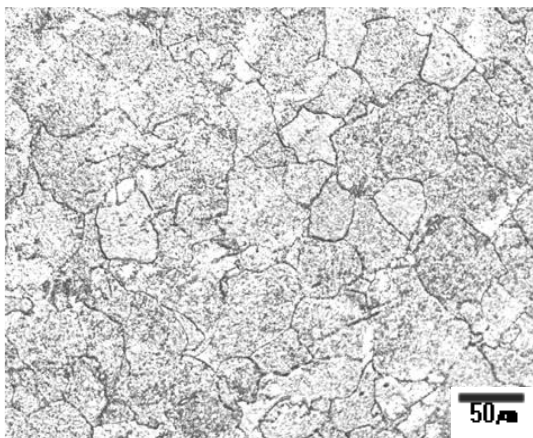
Figure 10. Replica test results of the tube B-37

The above microstructure shows structures mixed of ferrite and pearlite phases. Fe₃C carbides decomposed into small particles and precipitated in grain boundaries. The degradation degree of tube B-37 is evaluated to be in grade C. There is no detection of creep cavities, micro-cracks, inclusion, or segregation. The tube is not carbonized. We can conclude that the radiant heater tubes are not carburized. The degradation degree is in grades C and D. The residual life is 40~60%.

8. Pay special attention to severe partial thermal oxidation and wall thickness reduction by localized corrosion in every periodic inspection, and recheck after 2 years with a replica test.
