## Implementation of risk-based inspection approach on catalytic reformer heater tubes

*Risk based inspection, damage mechanism, failure, heater tubes, API 580.*

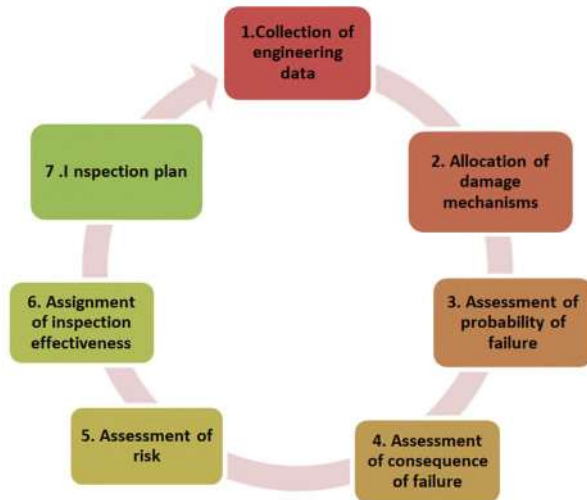
Figure 3. RBI assessment process [1,11].

The RBI methodology adopted for the heater is semi-quantitative. It is in compliance with the API RP 580 standard. The figure 3 summarizes the methodology adopted for the RBI assessment process.

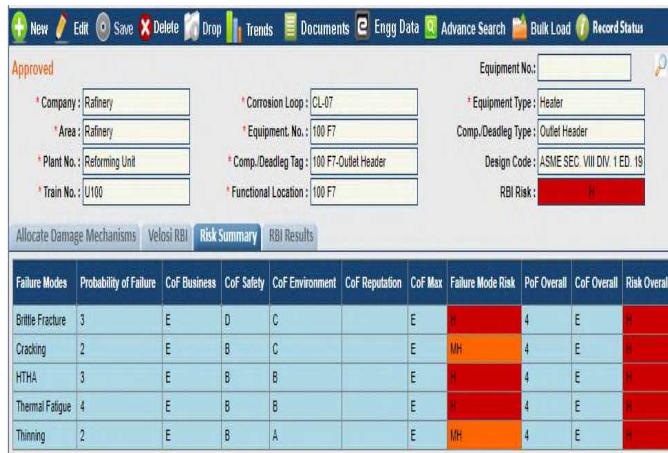
Figure 4. Radiant tube risk summary logical [23]

Figure 4 shows a risk summary related to radiant heater tubes, illustrating the risk levels for each mode of failure associated with each damage mechanism, along with the overall risk.

The criticality assessment conducted for the radiant tubes revealed that these components are predominantly classified within the High (H) criticality category, positioning them in the red zone of the risk matrix. This classification reflects the severe operational risks associated with the radiant tubes and demonstrates that they represent some of the most critical components within the catalytic reformer heater. The high criticality level is the result of the combined influence of elevated Probability of Failure (PoF) values, severe Consequence of Failure (CoF) ratings, and the simultaneous presence of multiple active damage parameters acting under high-temperature operating conditions.

The Probability of Failure analysis showed that the radiant tubes are mainly assigned a PoF level of 4 for several identified degradation parameters, indicating a high likelihood of failure during operation. This elevated probability is primarily associated with the harsh service conditions experienced by the tubes, including prolonged exposure to elevated temperatures, cyclic thermal stresses, internal pressure, and aggressive process environments. Furthermore, the coexistence of several severe degradation parameters considerably increases the overall susceptibility of the tubes to failure.

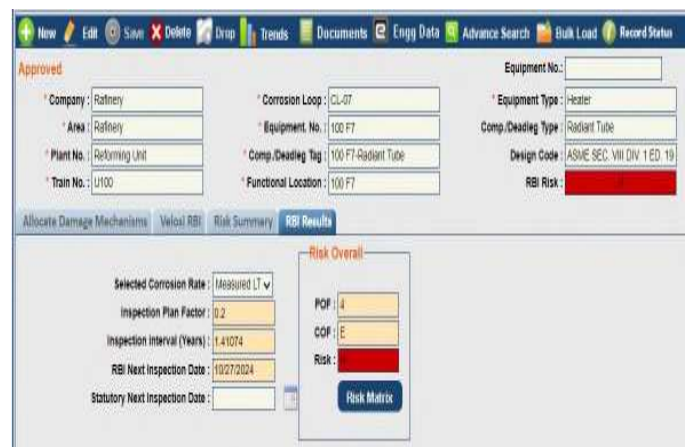
Figure 5. Overall risk result for the RBI study [23]

The software calculates the next inspection interval by analyzing prior data on equipment risk, inspection effectiveness, historical corrosion rates, and remaining life. Based on this analysis, it has set the inspection interval at 1.41074 years displayed in figure 5, determining the optimal frequency for evaluating the equipment to maintain safe operations. Using this interval, the software predicts the next inspection date as October 27, 2024.

Based on the assessment, the risk classification for this equipment is deemed high, placing it in the red zone. This classification highlights the urgent need for attention and reinforces the importance of adhering to the specified inspection interval to mitigate potential issues.
