Risk Assessment and Structural Restoration of Roman Cisterns at the Regional Theatre of Skikda, Algeria

This study is part of a comprehensive initiative focused on the restoration and adaptive reuse of Roman cisterns located beneath the Regional Theatre of Skikda, Algeria. As a key component of a broader heritage conservation strategy, the project supports the structural rehabilitation and functional reintegration of historical infrastructure, while prioritizing public safety and the preservation of architectural heritage. The primary objective is to implement a comprehensive structural diagnostic assessment, using non-invasive and semi-invasive techniques to detect and map pathologies in the load-bearing elements, fixed installations, joints, and historical construction materials. Key issues, such as material degradation, cracking, fractures, and aging, are examined, with a focus on identifying root causes through systematic analysis. The diagnostic process integrates traditional surveying with modern techniques, including visual inspection, material sampling, and structural behavior modeling, to ensure accurate evaluation and informed decision-making. A secondary objective of th

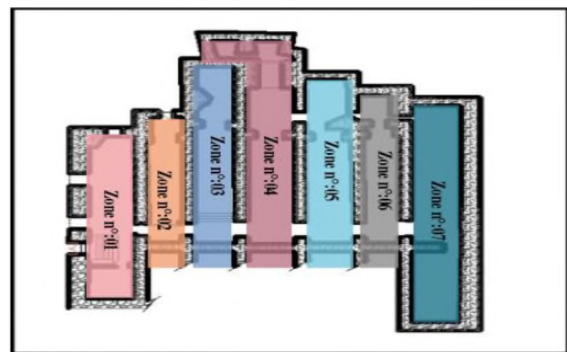
Figure. 2 Plan view showing the seven component sections of the vault system.

The Roman cisterns, which constitute the foundational substructures of the current Regional Theatre, consist of

seven compartments. These compartments are constructed using load-bearing masonry walls made from stone (Figure 3).

Roman builders commonly used brick and Roman concrete, a highly durable composite material composed of lime, sand, gravel, and stone fragments. In this particular case, the vaults are of the barrel vault type—a continuous, semi-cylindrical structure made of brick, characteristic of Roman engineering.

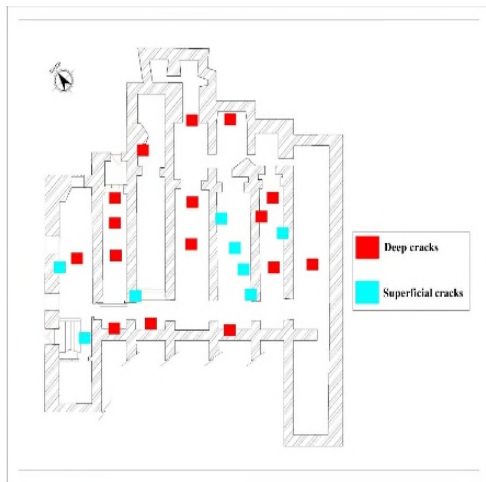
Figure. 3 Mapped Structural Pathologies – Cracking

- Cracking in the masonry vaults and walls (Figure 3).
- Moisture infiltration and humidity-related damage (Figure 4).

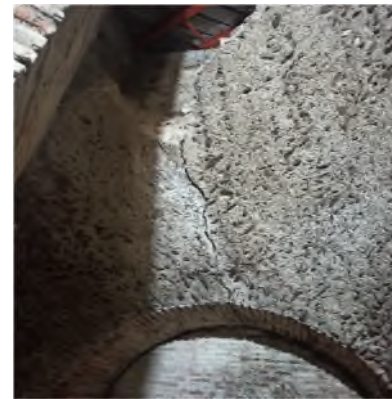
Significant cracking was observed across multiple interior wall segments (Figure 5).

Figure. 5 Crack observed on the interior wall.

For the treatment of oblique and linear cracks on the interior walls, the following measures are recommended:

- Filling the cracks in the affected walls using appropriate repair materials.
- Reconstructing severely deteriorated sections to restore structural integrity.
- Eliminating sources of rainwater infiltration to prevent further damage and moisture-related issues.

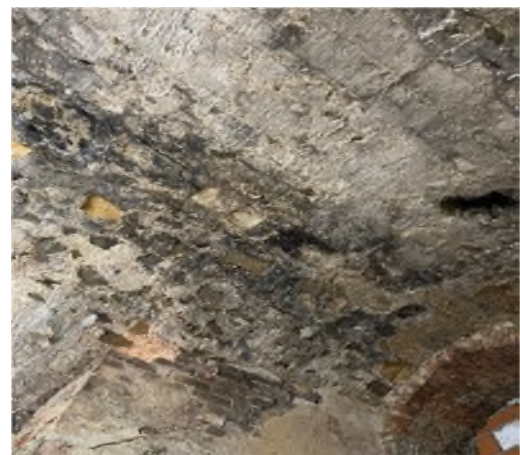
Black mold was observed on the vault surface (Figure 6). The recommended treatment procedure includes:

Figure. 6 Black mold growth on the vault surface.

- Washing the affected areas with a suitable façade cleaner, followed by thorough rinsing.
- Applying a fungicidal treatment to eliminate mold spores and prevent recurrence.
- Coating the surface with an acrylic insulating paint to protect against moisture penetration and future biological growth.

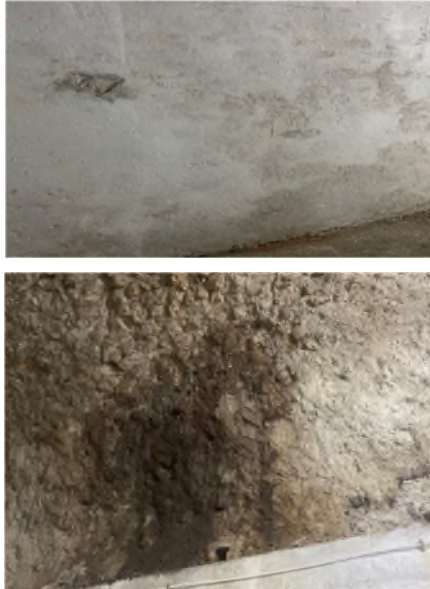
Moisture-related deterioration is evident on the vaults and walls, characterized by visible moisture stains (Figure 7). The remediation measures include:

Figure. 7 Moisture stains on vaults and walls.

- Partial replacement of stones or bricks exhibiting significant damage.
- Identification and elimination of all sources of water infiltration to prevent recurrence [9], [10].

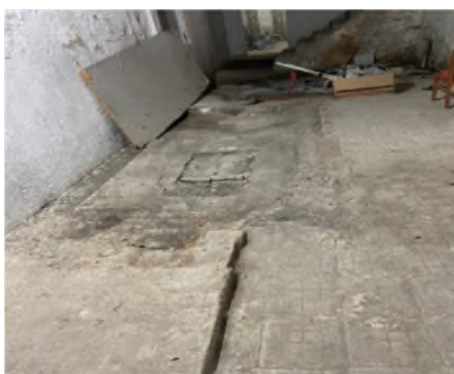
Figure 8 illustrates the condition of the interior finishes. The treatment procedure includes:

Figure. 8 Condition of the interior finishes.

- Removal of existing overlays, followed by excavation down to the desired floor level.
- Installation of a new stone flooring finish.

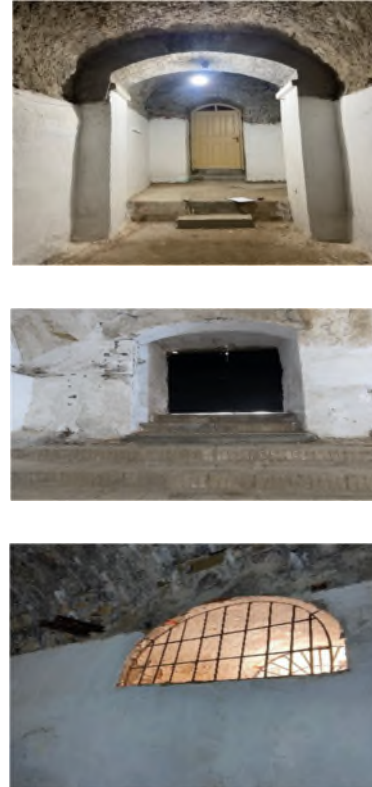
Figure 9 shows the deteriorated state of the carpentry elements. The proposed treatment includes:

Figure. 9 Damaged carpentry elements.

- Replacement of damaged doors and windows.
- Installation of new doors in accordance with the proposed layout plan.
- Repainting of severely deteriorated metal elements using moisture- and corrosion-resistant paint.

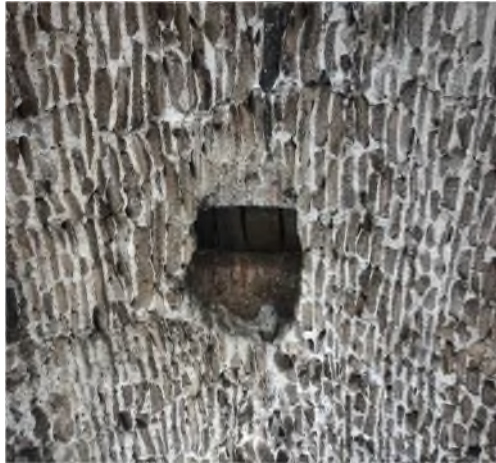
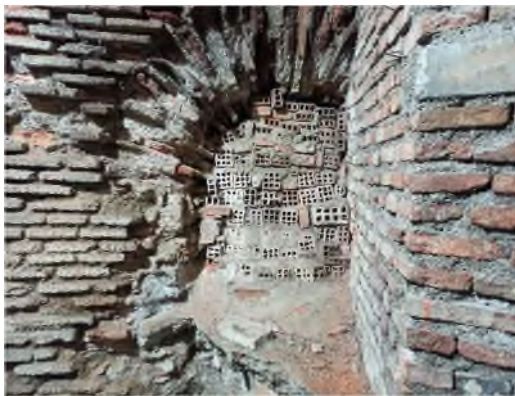
As illustrated in Figure 10, the masonry walls exhibit signs of stone deterioration. The proposed restoration procedure comprises the following actions:

Figure. 10 Degraded masonry observed on wall surfaces.

- Material Condition Survey: Conduct a detailed assessment to identify various forms of degradation, including cracks, surface erosion, biological colonization

(such as moss or algae), and general soiling.

- Non-Aggressive Cleaning: Perform gentle surface cleaning using soft-bristle brushes or low-pressure water systems to remove contaminants without altering or damaging the original stone texture.
- Structural Consolidation and Surface Repair: Stabilize weakened zones through appropriate methods. This may include resin injection to improve internal cohesion or the application of compatible repair mortars to seal cracks. Severely degraded stone elements can be reconstituted using specialized stone patching techniques [11], [12].
- Selective Replacement: Elements that are too deteriorated to be salvaged should be replaced using

materials that are physically and aesthetically compatible with the original masonry, in order to preserve structural integrity and visual coherence [13], [14].

- **Protective Finishing:** Apply a breathable hydrophobic treatment or protective coating to enhance durability and water resistance, ensuring moisture vapor can still escape from the masonry to prevent internal condensation or decay.

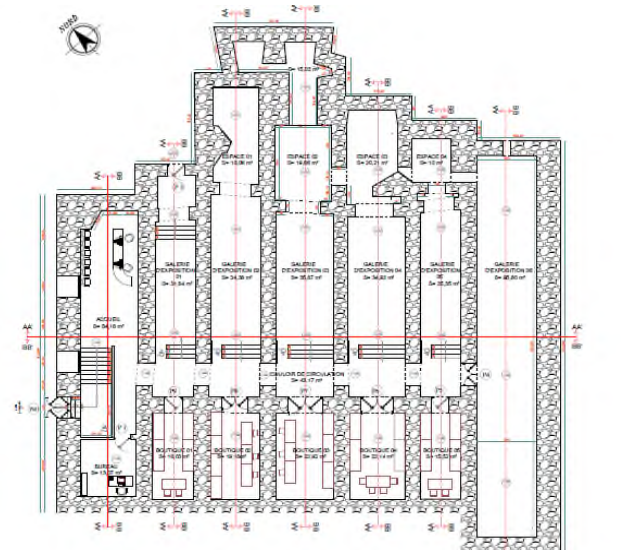
Figure. 11 Roman Cisterns Converted into Art Gallery

- Conversion of the vaulted spaces into exhibition galleries [15].
- Allocation of dedicated areas for creative workshops.
- Extension of the vaults to incorporate new art retail spaces (Art Shops) (Figure 11).

Plan View – Cisterns Converted into Gallery

Section AA – Modified

Section BB – Modified

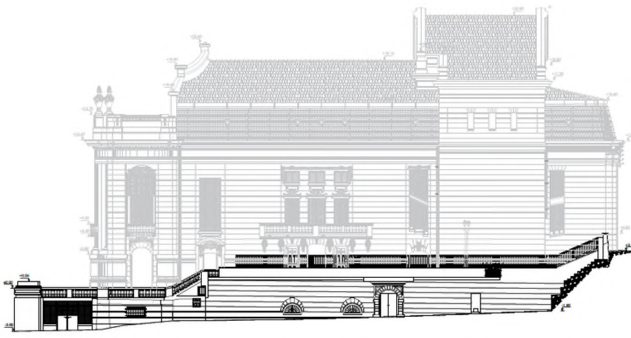
Figure. 12 Upgraded Main Façade

The façade in question is located to the right of the theater’s main entrance and shares a service courtyard with the adjacent courthouse, providing vehicular access for service vehicles and delivery vans. The façade is composed of two levels: upper and lower. The lower level includes two main access points: one leading to the library, and the other providing entry to the theater’s basement level, where the Roman cisterns are located (Figure 12).

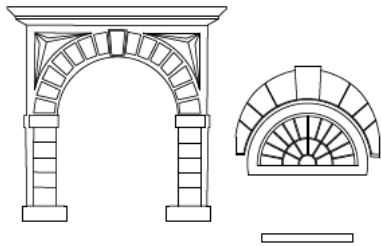
Figure. 13 Façade Detail

Given that this façade mirrors that of the theater’s garden side, the proposal includes the addition of architectural details aimed at enhancing its visual quality and clearly marking the entrance to the new art gallery (Figure 13).
